TURBOMACHINERY & PUMP SYMPOSIA | HOUSTON, TX
AUGUST 20-22, 2024
SHORT COURSES: AUGUST 19, 2024

THRUST BEARING FAILURE IN A LARGE LNG REFRIGERATION COMPRESSOR

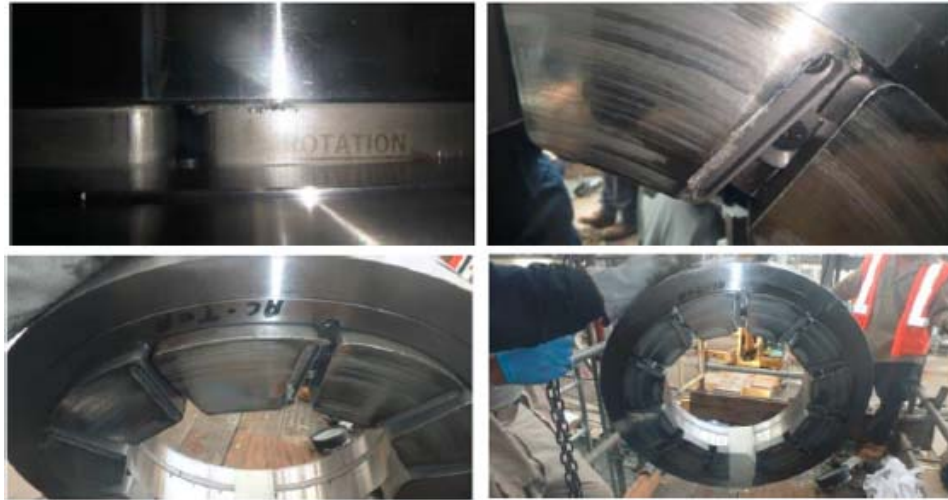
In second quarter of 2015, a dry gas seal failure occurred on one of the refrigeration compressors requiring it to be shut down for repair. In the process of removing the dry gas seal it was discovered that the active thrust bearing had been damaged. The bearing had not failed, though the babbitt had started to wipe showing evidence of excessive load (Figure 2). This was a surprise, because there had not been any evidence of pending thrust bearing issues (i.e. temperature and axial position were both below alarm levels). The active side of the thrust bearing was replaced, and the compressor was re-started without incident.

FIGURE 2. Thrust bearing damage discovered during DGS replacement in July 2015

The wear indications in all the inspections (Figures 2, 5, and 7) shows that all the pads appear to be carrying approximately the same load. Furthermore, there are no unusual bruises or asymmetric babbitt distress, and the wear patterns do not indicate an installation error. The low temperature rise and small axial position ranges at nominal operating conditions suggest that the bearing was installed correctly.

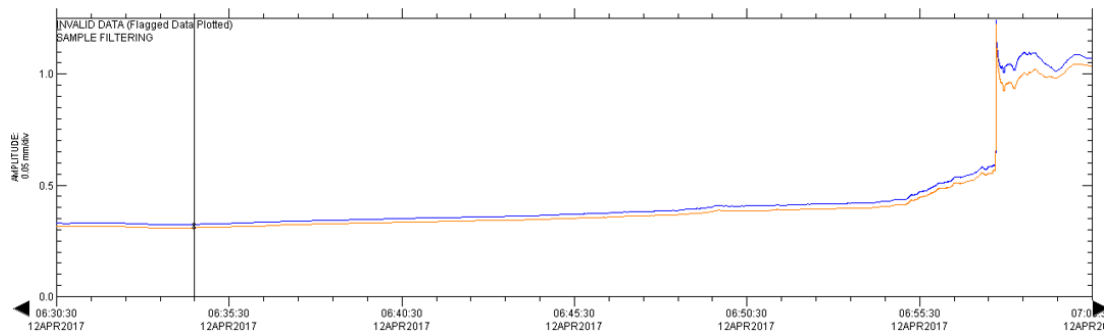
In April 2017, a process upset occurred which caused one of the Fr 7 refrigeration trains to trip. The remaining compression train went on total recycle, which caused all the suction and discharge pressure to increase. Eventually, this led to an active thrust bearing failure as is evident from the thrust position and temperature trends in Figures 3 and 4. The axial position increased from 0.3 to 1.25 mm (0.012 to 0.049 inches) (the designed total mechanical float was 0.5 mm (0.02 inches) and the active thrust temperature increased from 70 to 340°C (158 to 640°F)). The beginnings of the trends show how lightly the thrust bearing was normally loaded (i.e. 50% of the mechanical float and approximately 20°C (36°F) temperature rise). The rotor moved so far that all the babbitt was wiped from the thrust pads and the steel shoe contacted the thrust collar, damaging it as well (Figures 5-6). A root cause analysis (RCA) was conducted to determine the cause of the thrust bearing failure. Several root causes were considered and eliminated. The final root cause was never determined. As part of this RCA, the controls and operations procedures were modified to not allow the compressor to pressure up so much during plant process upsets. Also, plant feed was reduced earlier when one of the compression trains tripped to reduce the possibility of overloading the remaining train.

FIGURE 3. Trend of thrust position from 12 April 2017

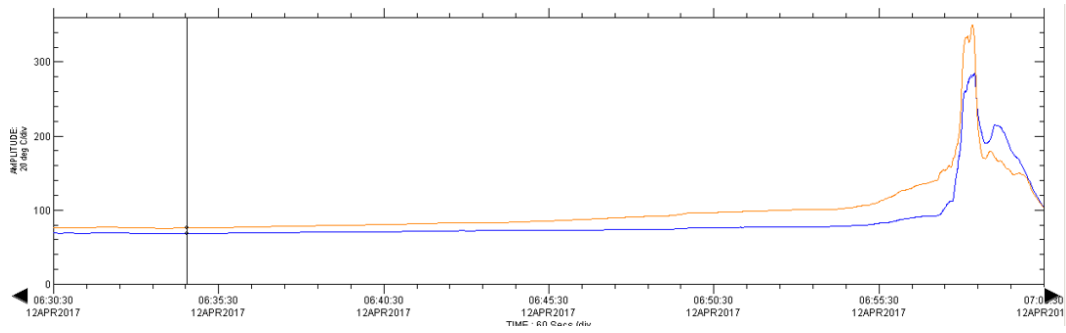
FIGURE 4. Trend of active thrust temperature from 12 April 2017

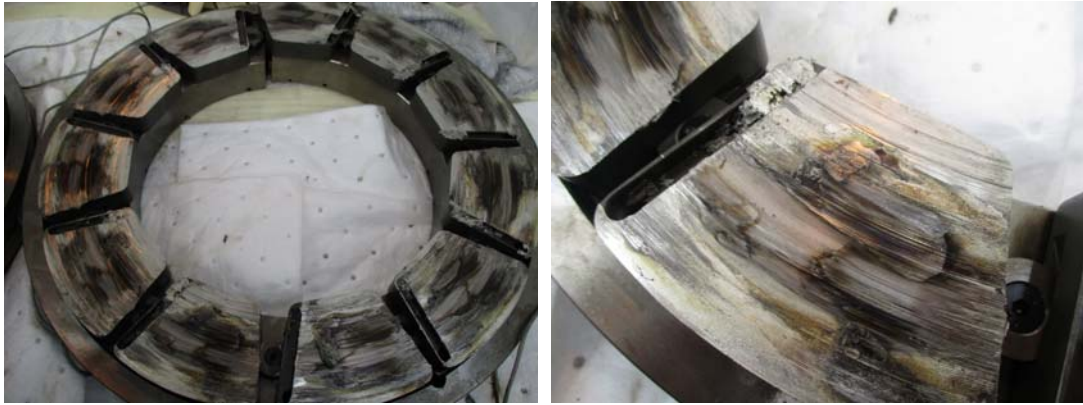
FIGURE 5. Failed active thrust bearing from April 2017 (close up on the right)

The physical evidence from the thrust bearing damage as well as failures all point to excessive load [Blair and Pethybridge 2010]. One of the key pieces of evidence is the “crowning” effect that is evident in both Figures 5 and 7. Crowning is the deflection of the thrust pad around the pivot due to load. Figure 7 is especially noteworthy since it presents distress to high load prior to catastrophic failure. Figure 5 is the bearing appearance after a catastrophic failure, and clues are masked due to widespread damage and introduction of other distress modes. The bearing OEM did not have the opportunity to examine distressed bearing components, making Figure 7 especially valuable.

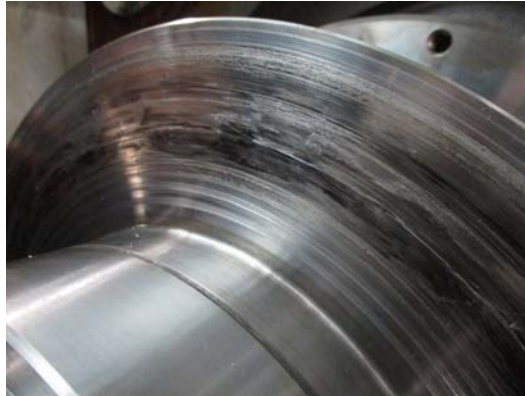
FIGURE 6. Damaged thrust collar from April 2017

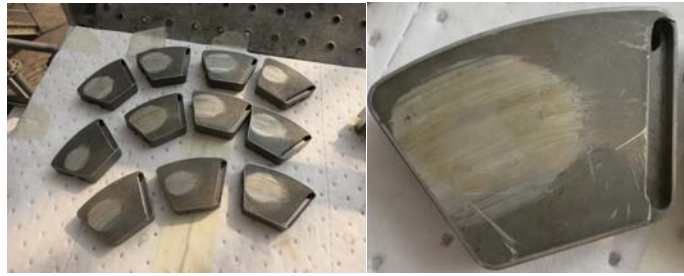
In July of 2018, the LNG facility was brought down for a scheduled turnaround (TAR). Between the April 2017 failure and July 2018, the axial position and thrust temperature readings were normal, with the exception that both indications increased momentarily whenever the compressor shutdown. As part of the TAR, the thrust bearing was inspected to determine its condition. The mechanical float of the compressor was 0.05 mm (0.002 inches) above the maximum allowable and a visual inspection of the active pads showed that they had been heavily loaded and had started to wipe, see Figure 7. The active bearing pads were replaced, which returned the mechanical float within the allowable range. While the pads in these pictures are not close to failure, they do indicate that the bearing appears to be loaded much heavier than the axial position and thrust temperatures indicate. Additionally, they provide some additional clues to the possible cause of failure, which will be discussed in the next section.

FIGURE 7. Active thrust pads removed in July 2018 (close up on right)

pressure does not drop during shutdown, see Figure 8. Further confirmation that adequate lubrication is present is the condition of the pads in Figure 7. Insufficient lubrication oil would result in burnt/varnished oil on the pads, however these pads only show evidence of higher load. Additionally, there are four other machinery casings in the train (one gas turbine, two other centrifugal compressors, and one helper motor) that all share the same lube oil system and none of them have had a bearing failure due to insufficient lubrication.

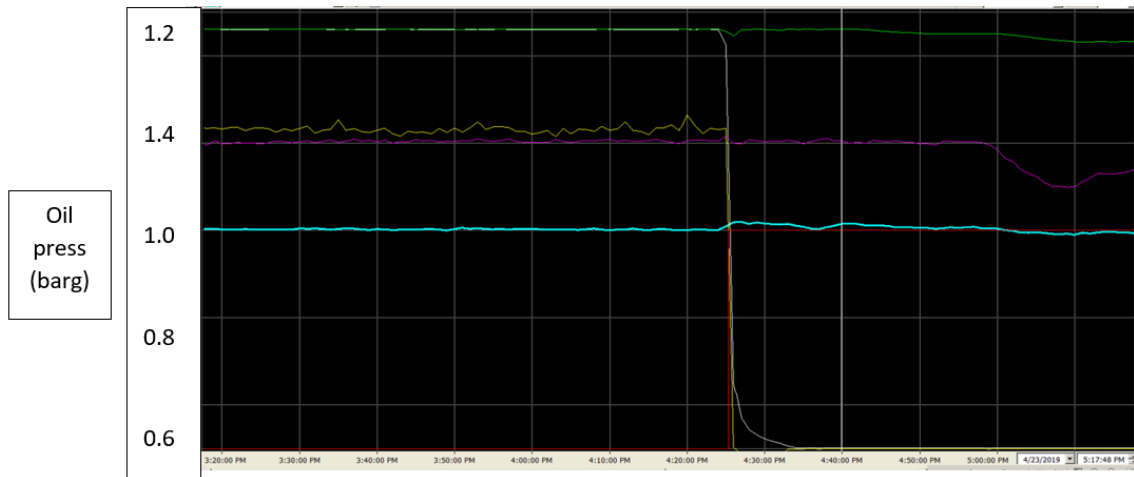
Initial concern by the compressor OEM was that the bearing was somehow losing lube oil pressure on coast down (this theory also addressed why the temperature would spike on shutdown). Furthermore, it was determined that the size of the flow orifice on the thrust bearing supply had been changed since the original design from 32 to 25 mm (1.26 to 0.98 inches). However, flow calculations confirmed that the 25 mm (0.98 inch) orifice is large enough to supply the required flow rate, as determined by the bearing OEM. Additionally, a pressure transmitter was installed downstream of the orifice on the thrust bearing supply line which verified that the

FIGURE 8. Lube oil pressure (light blue) when compression train shuts down, compressor speed (white)

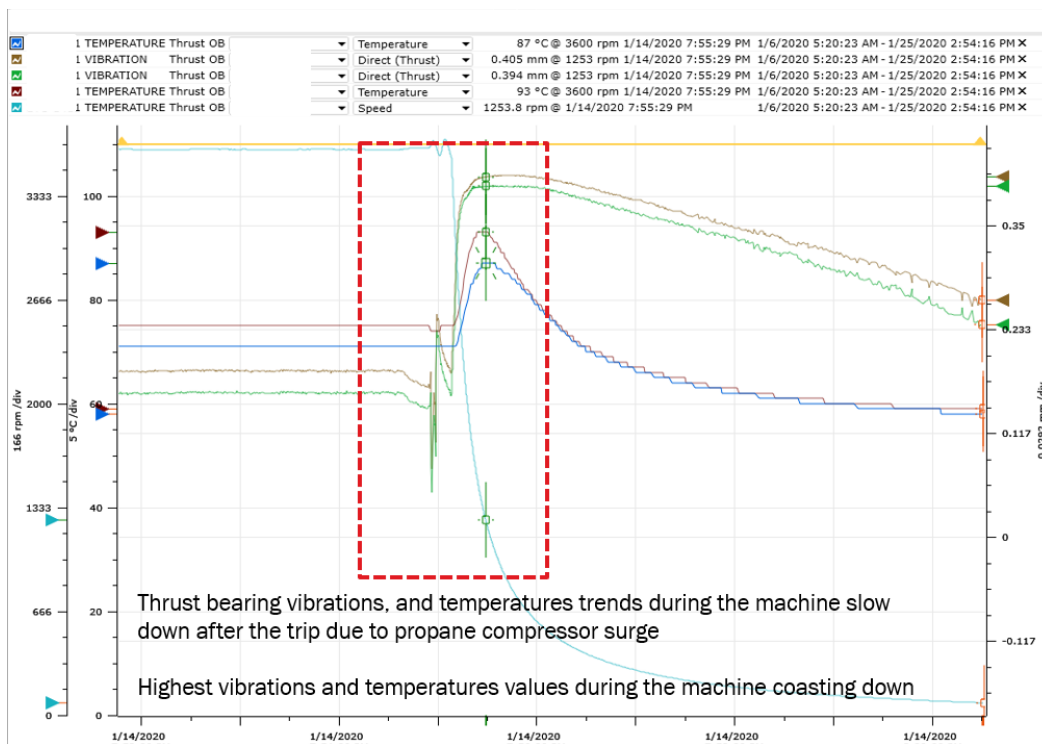
FIGURE 10. Compressor axial position and active thrust bearing temperature during trip on 14 Jan 2020

Referring to Figure 10, as the machine speed slowed to approximately 3000 rpm the thrust bearing temperatures sharply increased, indicating the onset of bearing distress. The bearing temperatures reached a maximum of approximately 93°C (200°F) as the rotor speed slows to 1250 rpm. This occurred approximately 21 seconds after the compressor trip. As stated above, the evidence at hand suggested bearing distress was created by high thrust load, but the source and magnitude were initially unknown. Information presented in Table 1 and Figure 10 was used to extract approximate load values at noteworthy transition points. The bearing OEM relied on in-house code to identify the load required to generate temperatures measured during the upset event. The code is based on experimental results from extensive in-house high speed bearing testing. The analysis revealed a maximum load of approximately 320 kN (72000 lbf), or 5.2 MPa (758 psi) unit load (i.e. 128% of the rated load). Equipped with this information, a detailed evaluation of the load source and thrust pad design could begin.

A further review of the thrust temperature shown in Figure 10 was made to compare the calculated thrust load from the pressure with the bearing OEM predictions of metal temperature for a given load. The process data from the Jan 14, 2020 trip was used to calculate the pressure load on the bearing and found to be 84% of the rated load or approximately 210 kN (47200 lbf). The bearing OEM was asked to predict the load required to produce a metal temperature of 93°C (200°F) at 1250 rpm. Their calculated value was 338 kN (76000 lbf) (135% of the thrust bearing capacity). This difference suggests that either the pressure load is greater than predicted or the bearing has already been damaged. An additional uncertainty exists in this comparison that would cause the difference between the two calculated loads to be even greater. The peak in thrust temperature in Figure 10 happens very quickly. If the load was held at this value for an extended period, the metal temperature would undoubtedly have gone up even more. Temperature measurements are normally only accurate during steady state events. This would result in an even higher calculated load.

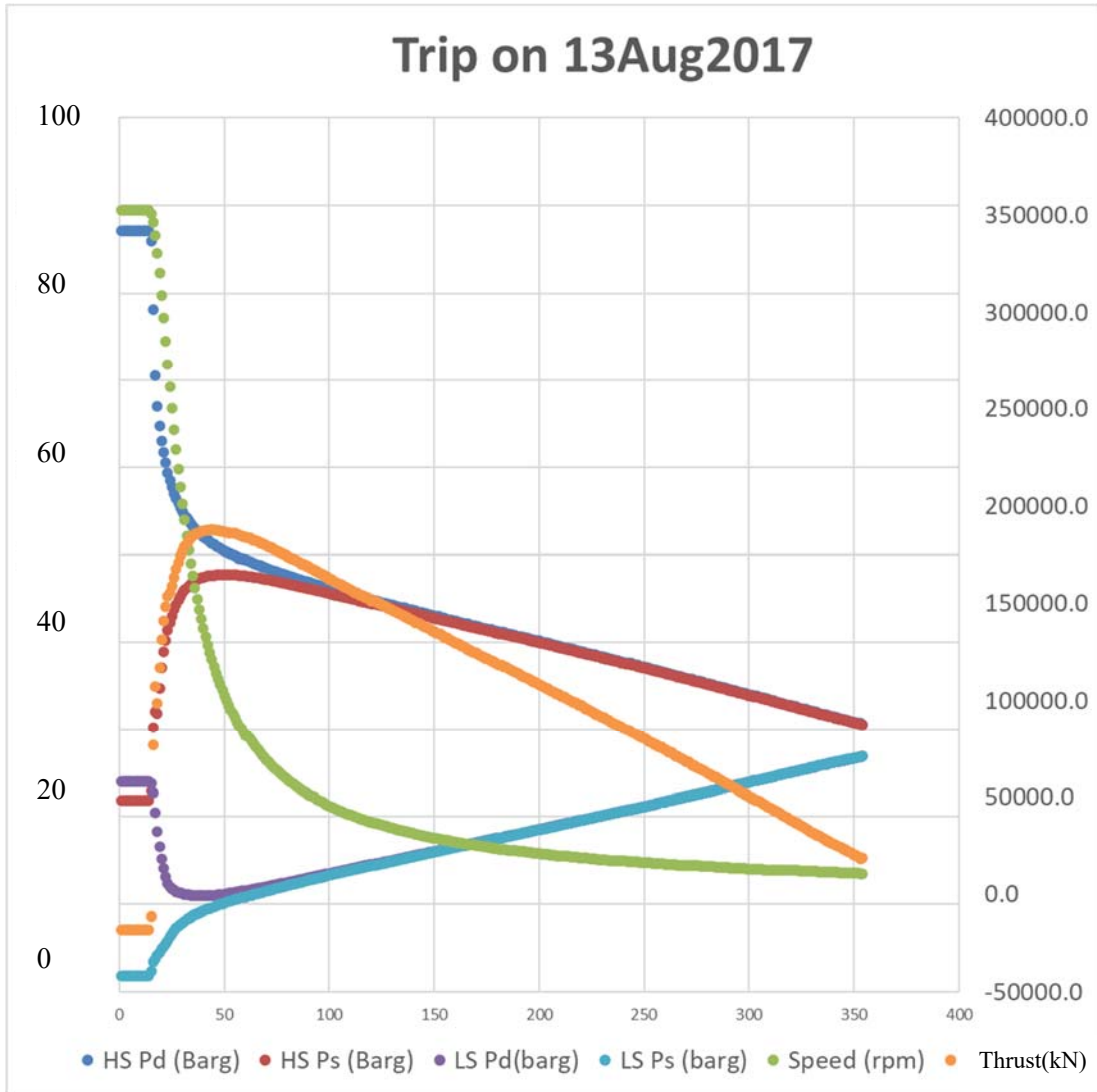
The initial settle-out to two different pressures causes a high thrust load on the rotor pushing it in the active direction (right to left in Figure 11). High speed process data was obtained from the anti-surge controller for a trip of the compressor on 13 August 2017 (Figure 13). The gold line is the calculated thrust load and the green line is the speed. As described above, the peak thrust load occurs about 25 secs after the machine trips when the speed is approximately 1500 rpm. Notice the similarities between the thrust temperature in Figure 10 above and the calculated thrust load in Figure 13 below. The two trends are very representative of each other. A more severe trip occurred on the other compressor on 25 June 2017 when the HP discharge pressure was higher, see Figure 14. The large differential

FIGURE 13. Compressor calculated thrust load (gold) and speed(green) based on 13Aug2017

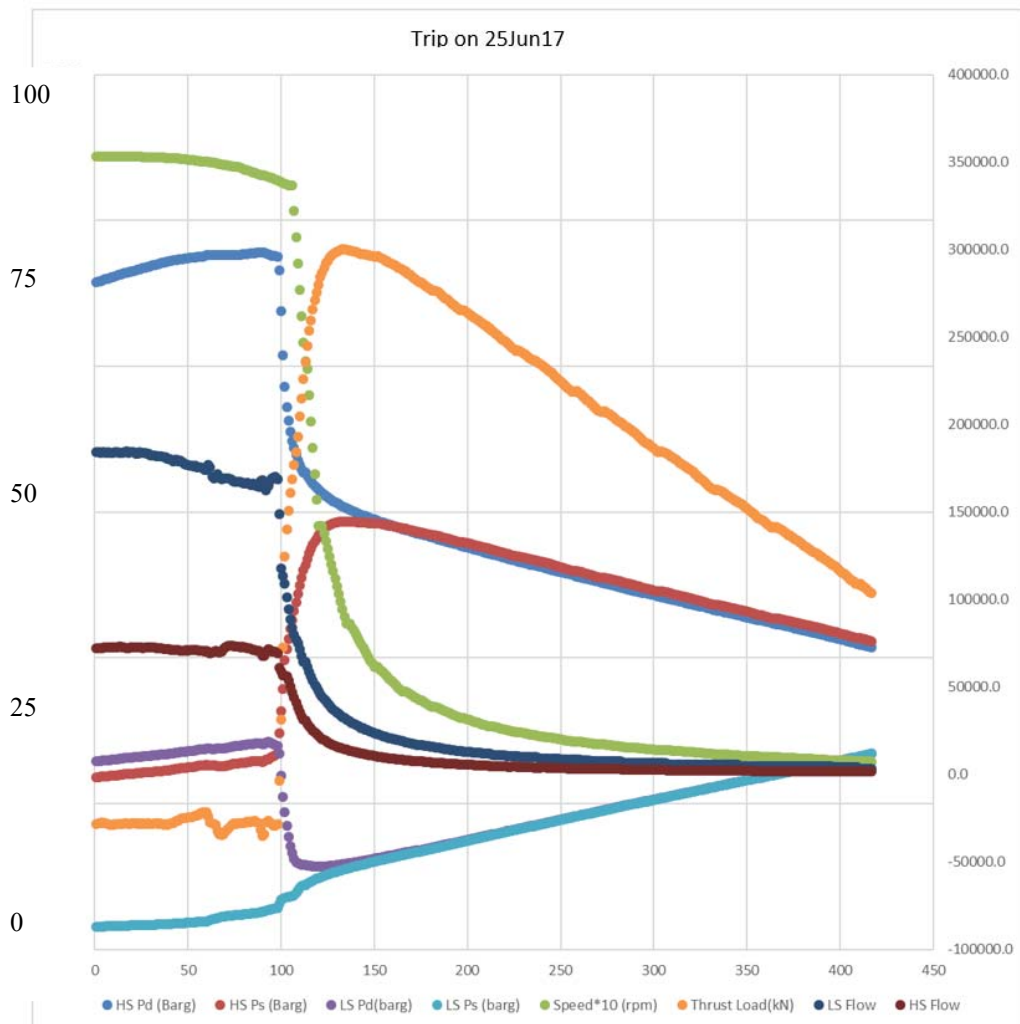
pressure between the LP and HP sections' settle-out pressures causes the peak thrust load to be much higher than that during normal operation.

FIGURE 14. Compressor calculated thrust load (gold) and compressor speed (green) on 25Jun2017

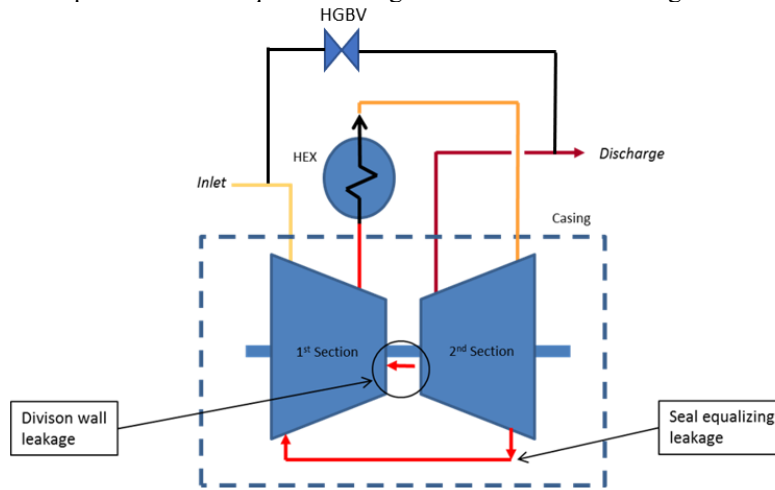
FIGURE 15. Compound compressor with Hot Gas Bypass Valve to reduce thrust load

The best solution to the high thrust load during the trip events is to reduce the load. This could be accomplished with the installation of a hot gas bypass valve (HGBV) illustrated in Figure 15. The HGBV rapidly equalizes the HP and LP section pressures when the compressor trips. This is very common on many offshore applications. However, it would be a very costly installation of a very large valve and piping. While a thrust bearing change would not be the total solution, if successful it would be much more cost effective than a HGBV. It is worth noting that the operator has another LNG facility with similar refrigeration compressors that do not have these issues because the two stages of compression are in *separate* casings which eliminates the high thrust load on shutdown.

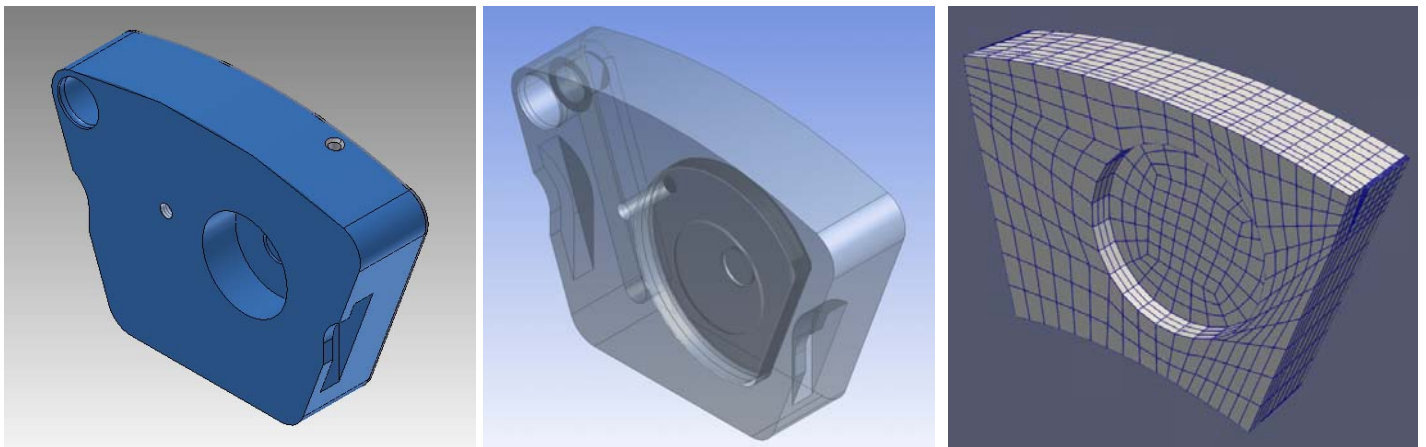
FIGURE 16: Sketch of the original shoe (left), the proposed solution (middle), and the computational model (right).

The task that lay before the bearing OEM was to come up with a drop-in-place replacement that could handle the unexpected excessive load. As discussed above, the key issue was the pad crowning. Most tilt-pad fluid-film thrust bearing designs concentrate the load applied to the pad surface to a point or line contact at the pad-support-to-leveling-plate or pad-support-to-base-ring (in the case of non-equalizing designs) interface. The most notable exception is the design with spring-bed supports. The initial bearing had a catalog-sized pad-support diameter and depth within the pad. The excessive load forced the pad to crown around the support as well as crush the pad-support-to-leveling-plate contact. The bearing OEM's experience is that a larger, thinner pad-support can mitigate large deflections: by making the pad-support radius larger, the pad has less unsupported material to flex, especially when the pad-support is hardened; in making the pad-support thinner, the body of the pad becomes thicker and thus less prone to flex under load. There is, of course, a limit to these modifications: the pad must still be able to flex to some degree for normal operation, and enough material must remain for the pad-support to not lose integrity under load.

Although the maximum thrust load was estimated to be approximately 320 kN (72,000 lbf), the goal was to put in the largest and thinnest pad-support possible to better ensure a successful outcome. The solution is shown in Fig. 16. Details are presented in Table 2. 3
