Troubleshooting Tilting Pad Thrust Bearings

BY WILLIAM STRECKER, KINGSBURY

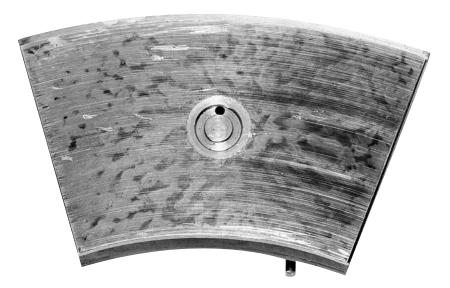
Figure 2. Thrust Shoe Surface Abrasion

Abrasion damage will cause a bearing surface to exhibit circumferential scratches (Figure 2). Abrasion is caused by hard debris, which is larger than the film thickness, passing through the oil film. The debris may embed itself in the soft babbitt, exhibiting a short arc on the shoe surface, ending at the point the debris becomes embedded.

continue across the entire shoe surface. Abrasion damage becomes worse as time progresses. Surface scratches allow an escape for lubricating oil in the oil wedge, decreasing

Depending on the debris size, the scratch may

the film thickness. This will eventually lead to a bearing wipe.

To eliminate abrasion damage, the lubricating oil must be filtered. If the oil cannot be filtered or has degraded, it should be replaced. It is important to evaluate the filtering system, because the problem may be an incorrectly sized filter. The filter should pass only debris smaller in size than the predicted bearing minimum film thickness.

In addition to filtering or replacing the oil, the entire bearing assembly, oil reservoir and piping should be flushed and cleaned. The original bearing finish should also be restored. Journal shoes typically must be replaced, but if the correction leaves the bearing within design tolerance, the bearing may be reused.

Although the babbitted surface is usually damaged more severely, the rotating collar or journal surface must also be evaluated. Debris partially lodged in the babbitt may score the steel surfaces. These surfaces must be restored by lapping or hand stoning.

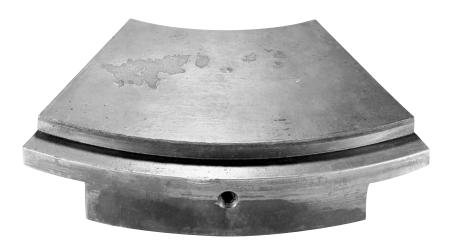
Figure 3. Tin Oxide Damage

Tin oxide damage is one of several electrochemical reactions which eliminate the "embedability" properties of a fluid film bearing. It is recognizable by the hard, dark brown or black film that forms on the babbitt (Figure 3).

Tin oxide forms in the presence of tinbased babbitt, oil and salt water, beginning in areas of high temperature and pressure. Once it has formed, it cannot be dissolved. and its hardness will prevent foreign particles from embedding in the babbitt lining.

This damage may be stopped by eliminating some or all of the contributing elements. The lubricating oil must be replaced. A reduction in oil temperature may also discourage the formation of tin oxide.

In addition to replacing the oil, the entire bearing assembly, oil reservoir and piping should be flushed and cleaned with mineral spirits. The bearing shoes should be replaced. The condition of the rotating journal, collar or runner surfaces must also be evaluated. They must be restored to original condition, either by lipping, hand stoning or replacement.

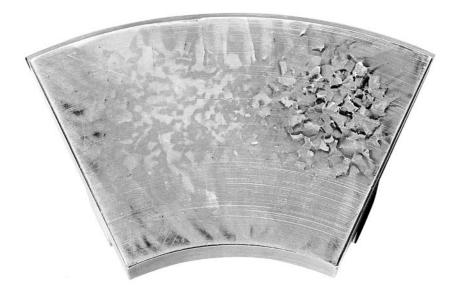
Figure 4. Thermal Ratcheting

Overheating damage may represent itself in many ways, such as babbitt discoloration, cracking, wiping or deformation. Repeated cycles of heating may produce thermal ratcheting, a type of surface deformation that occurs in anisotropic materials (Figure 4). These materials possess different thermal expansion coefficients in each crystal axis.

If thermal ratcheting has occurred, examine the shoes for the existence and depth of cracks.

Remove the cracks and restore the original shoe surface. If this cannot be done, replace the shoes. Journal shoes typically must be replaced, but if the correction leaves the bearing within design tolerance, the bearing may be reused.

The condition of the rotating journal, collar or runner surfaces must also be evaluated. It must be restored to original condition, either by lapping, hand stoning or replacement.

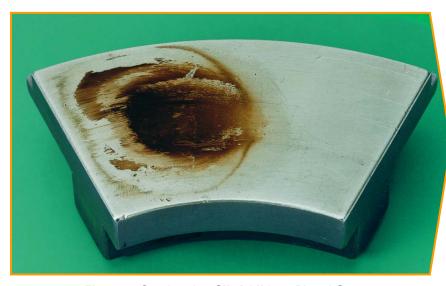
Figure 5. Overheating Oil, Additives Plated Out

Oil additive packages may plate out at relatively high bearing temperatures. The plating typically begins in the area of highest temperature, the 75-75 location (Figure 5).

Overheating may be caused by numerous sources, many of which concern the quantity and quality of the lubricant supply. Possible causes include:

- Improper lubricant selection
- Inadequate lubricant supply
- Interrupted fluid film
- Boundary lubrication

It is important to verify that the quantity and quality of oil flowing to the bearing is sufficient. These values should be available from the bearing manufacturer.
