## Preventing Electrical Pitting Damage

Electrical pitting damage, caused by intermediate arcing between stationary and rotating machine components, erodes the babbitted surface of a bearing, causing it to fail. With the right precautions, however, this type of damage can be prevented.

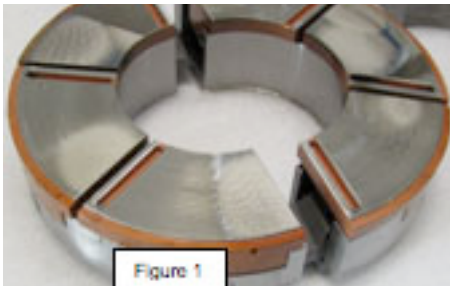
**When the bearing was removed from the machine, all the thrust pads showed some signs of distress, as shown in Figure 1.**

**Recommendations to prevent this type of damage:** Install grounding (or earthing) brushes on the rotor or by insulating the bearings. The source of the current should also be investigated.

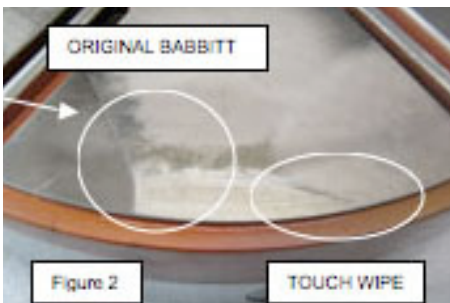
**In Figure 2, the original babbitt is only present at the leading edge of the shoe.** Evidence of a wipe can be seen toward the outer edge of the shoe. The areas at the trailing edge of the shoe and toward the inner diameter at the leading edge have clusters of small pitted marks.

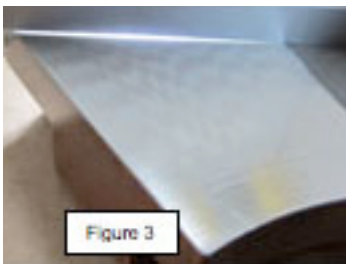
**There is a significant loss of babbitt toward the shoe's trailing edge, shown in Figure 3.**

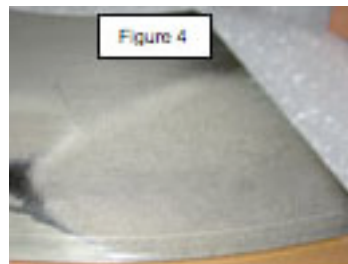
**Figure 4 shows a closer view of the pitted marks.** Note how they appear frosted. The babbitt is nearly gone at the trailing edge of the shoe as shown in Figure 5.

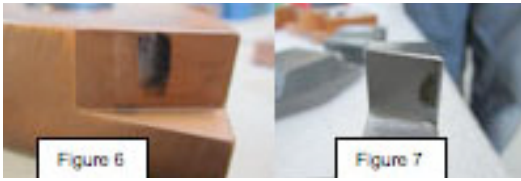
**Figures 6 & 7 show signs of burned oil in the contact area between the straddle mill of the shoe and base ring.**

**Figures 8 & 9 show signs of burnt oil in the contact area between the shoe's inner diameter and base ring.** The small pit marks and frosting on the shoes are classic examples of electrical pitting damage. This is caused by intermediate arcing between the stationary and rotating machine components. The electrical current travels through the path of least resistance, which is typically through the smaller oil films in the active or loaded thrust bearing. The pitting damage starts at the trailing edge of the shoe where the

film thicknesses are the smallest. As the babbitt is removed by the electrical currents, the tilt of the shoe changes until the load carrying area of the shoe is reduced. The damage gradually progresses towards the leading edge of the shoe. Eventually the bearing will not be able to support a load and will wipe.
