# A GENERAL GUIDE TO THE PRINCIPLES, OPERATION AND TROUBLESHOOTING OF **HYDRODYNAMIC BEARINGS**

*During every second of every day, machines all over the world are working to provide the products we demand. These machines rely on the successful support of bearings. If a machine goes off line, extreme pressure is placed on those involved to correct the problem(s). It is the intention of this presentation to assist the reader in problem solving by providing background information on hydro-dynamic bearings and distress modes.*

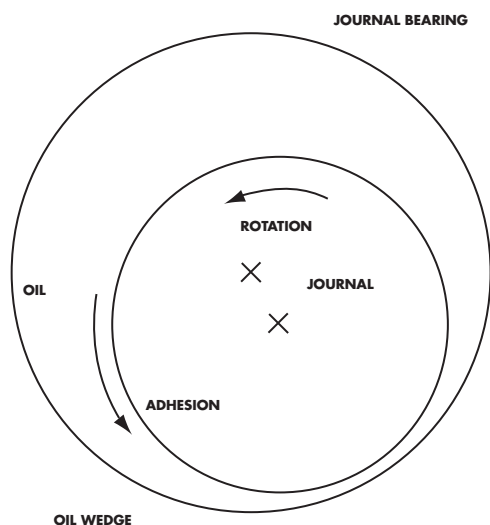
Figure 4 Hydrodynamic Principle

Based on his theoretical investigation of cylindrical journal bearings, Professor Osborne Reynolds showed that oil, because of its adhesion to the journal and its resistance to flow (viscosity), is dragged by the rotation of the journal so as to form a wedge-shaped film between the journal and journal bearing (Fig. 4). This action sets up the pressure in the oil film which thereby supports the load (Fig. 5).

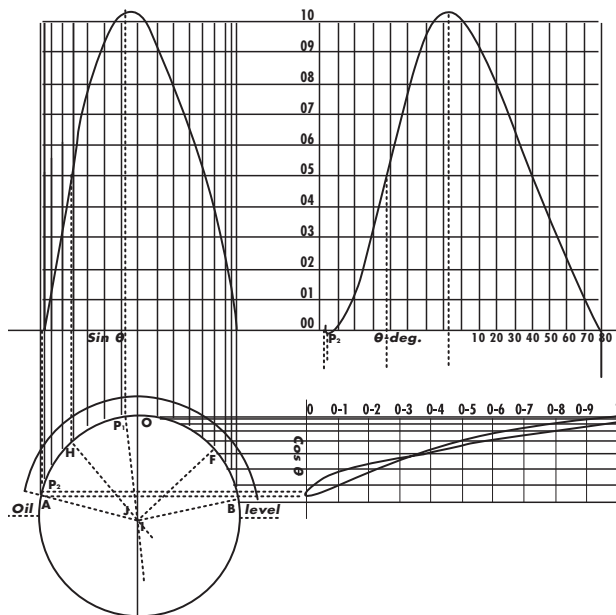
Figure 5 A figure from Reynold's Paper "On the Theory of Lubrication" showing oil film pressure distribution

This wedge-shaped film was shown by Reynolds to be the absolutely essential feature of effective journal lubrication. Reynolds also

showed that "if an extensive flat surface is rubbed over a slightly inclined surface, oil being present, there would be a pressure distribution with a maximum somewhere beyond the center in the direction of motion."

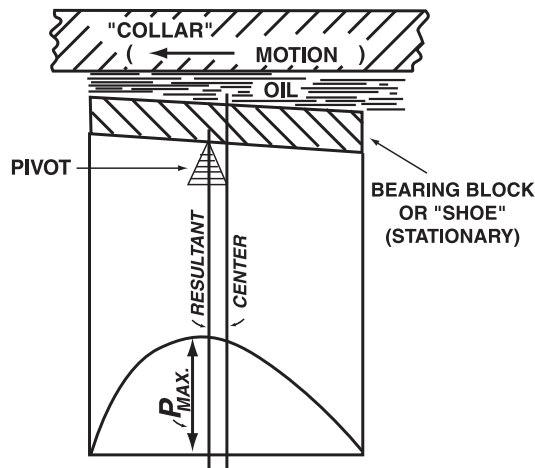
Figure 6 Illustration from a page from Albert Kingsbury's Paper "Development of the Kingsbury Thrust Bearing"

Applied to hydrodynamic tilting pad thrust bearings (Fig. 6) Albert Kingsbury stated: "If a block were supported from below on a pivot, at

about the theoretical center of pressure, the oil pressures would automatically take the theoretical form, with a resulting small bearing friction and absence of wear of the metal parts. In this way a thrust bearing could be made with several such blocks set around in a circle and with proper arrangements for lubrication.” The same concept applies to the tilting pad journal bearing.

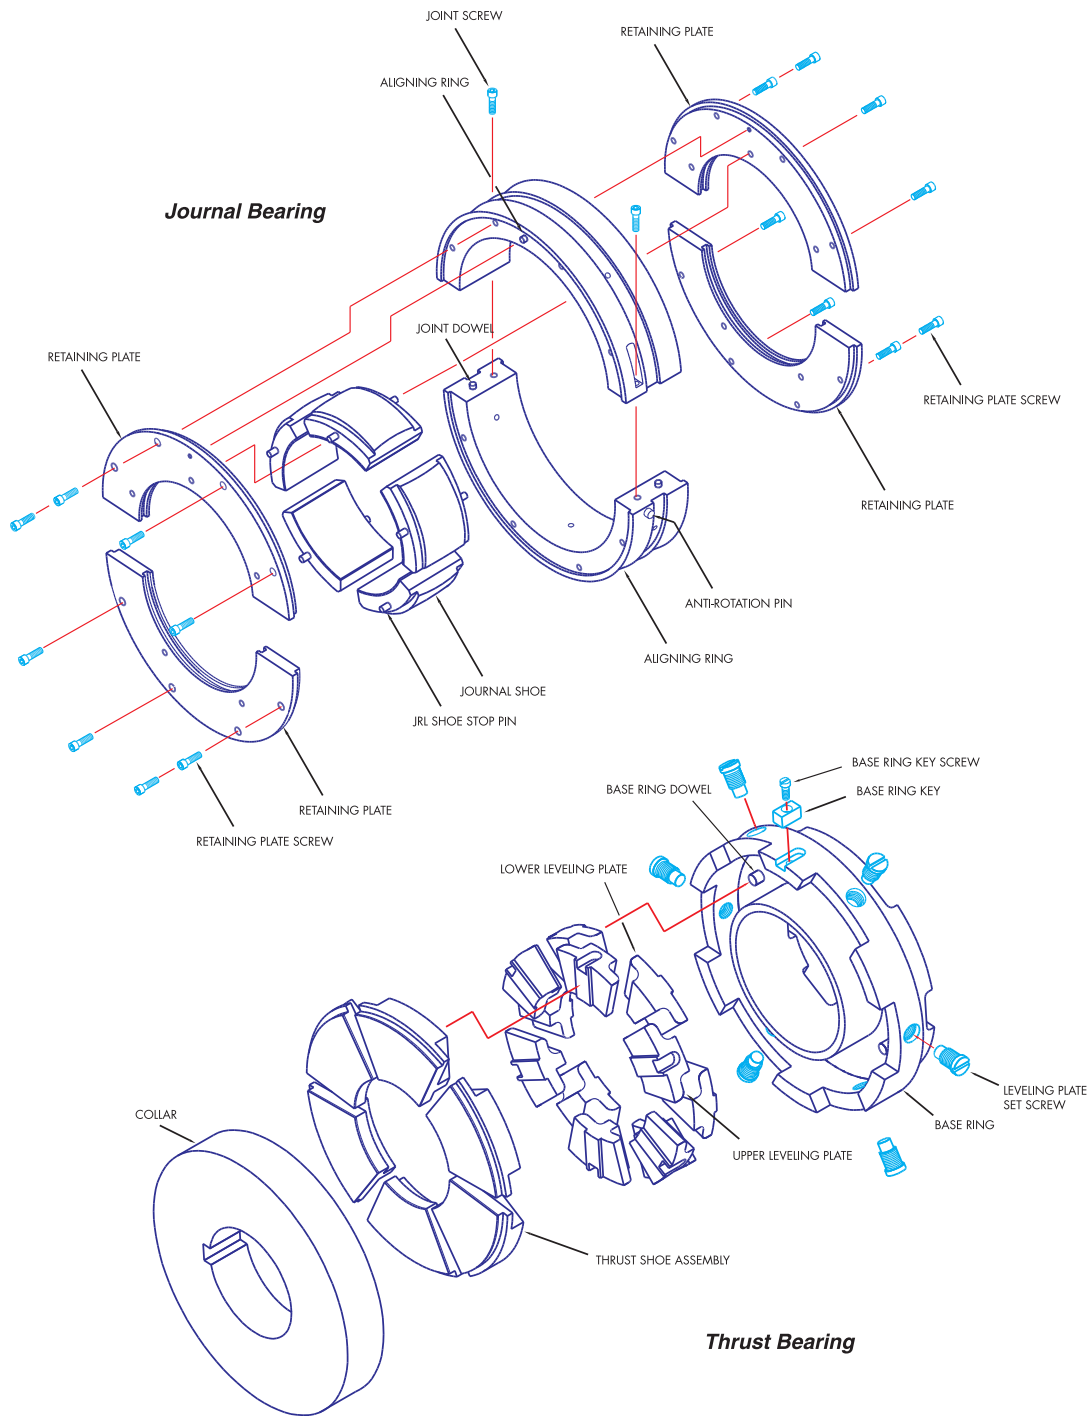
**Figure 7 Thrust and Journal Bearing Part Schematic**

The shoe (also called a pad, segment, or block) is loosely constrained so it is free to pivot. The shoe has three basic features - the babbitt, body, and pivot, and so is usually referred to as an assembly.

The babbitt is a soft material (compared to the shaft) which serves two functions: It traps and imbeds contaminants so that these particles do not heavily score or damage the shaft. It also protects the shaft from extensive damage should external conditions result in interruption of the film and the parts come in contact.

The base ring loosely holds and constrains the shoes against rotating so as to allow freedom to pivot. It may have passages for the supply of lubricant, and contain features to adapt for misalignment and tolerance in the parts. The base ring (aligning ring) is keyed or doweled to the housing to prevent rotation of the bearing assembly.

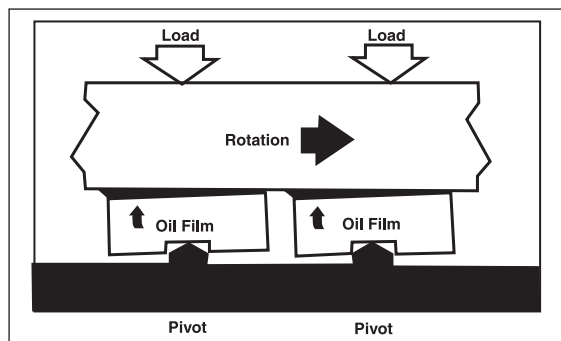
Figure 8-1 Pivoting Shoe Hydrodynamic Film Formation

The lubricant is another important "element" of the bearing (See Fig 8-1). The loads are transmitted from the shaft to the bearing through the lubricant which separates the parts and prevents metal-to-metal contact. The lubricant also serves to carry heat caused by friction out of the bearing.

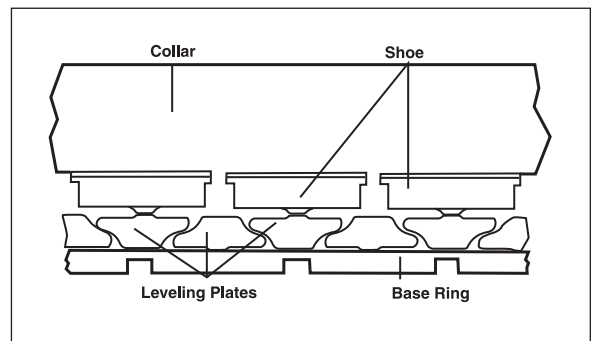
Figure 8-2 Thrust Bearing Load Equalization and Alignment Features

compensate for manufacturing tolerances by distributing the load more evenly between thrust shoes. The leveling plates compensate for minor housing deflections or misalignment between the collar and the housing's supporting wall. A description is given later under the section on misalignment.

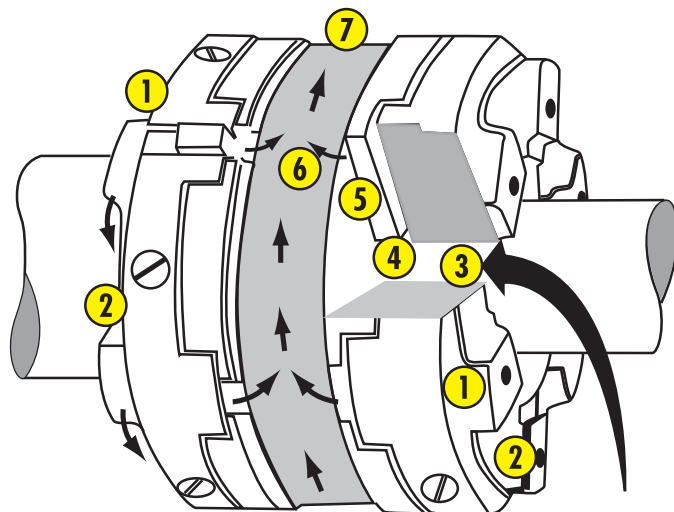
**Figure 10 Thrust Bearing Typical Oil Flow Path**

- 1 – Oil enters annulus in base ring.
- 2 – Oil passes through radial slots in back face of base ring.
- 3 – Oil flows through clearance between base ring bore and shaft.
- 4 – Oil flows to inner diameter of rotating thrust collar.
- 5 – Oil flows between shoes and into the films.
- 6 – At the collar rim, oil is thrown off into space around the collar.
- 7 – Oil exits tangentially through the discharge opening.

Various methods are applied to provide lubricant to the bearing surfaces. The bearing cavities can be flooded with oil such as vertical bearings which sit in an oil bath. The bearings can also be provided with pressurized oil from an external lubricating system. The flow path of a horizontal, flooded **tilting pad** thrust bearing is shown in Figure 10.

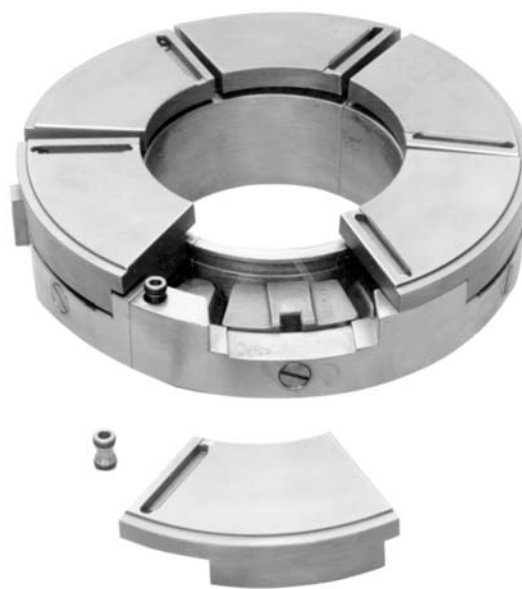
**Figure 11 Leading Edge Groove (LEG) Thrust Bearing**

In 1984 Kingsbury introduced its Leading Edge Groove (LEG) Thrust Bearings (Fig. 11), another technology developed for high tech machines. In addition to reducing oil flow and power loss, LEG lubrication greatly reduces the metal temperature of the shoe surface. This effectively reduces oil flow requirements and power loss while improving the load capacity, safety and reliability of the equipment. Rather than flooding the bearing or wetting the surface, the LEG design introduces cool oil directly into the oil film (Fig. 12), insulating the shoe surface from hot oil that adheres to the shaft. The same technology is applied to tilting pad journal bearings (Fig. 13).

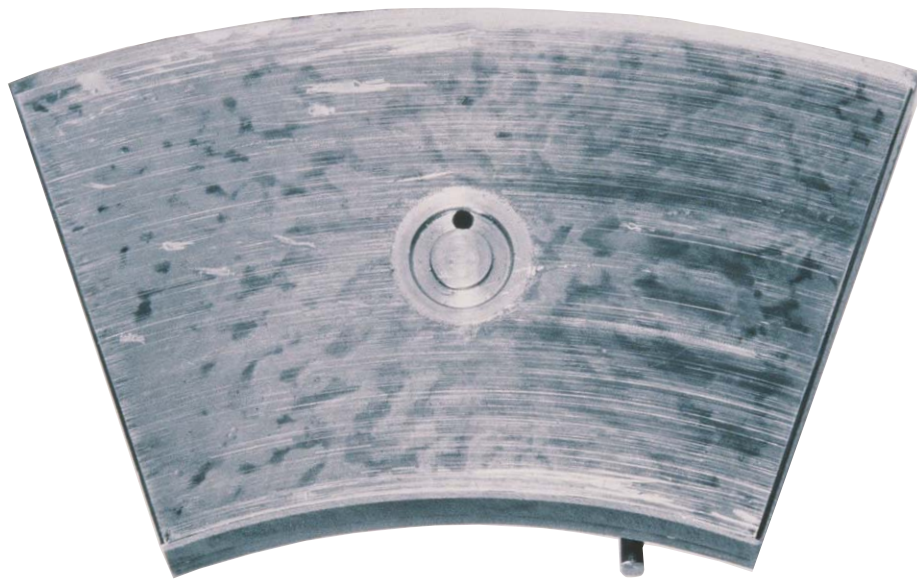
Figure 15 Thrust Shoe Surface Abrasion

A bearing surface exhibiting circumferential scratches is the result of abrasion damage (Fig. 15). Abrasion is caused by hard debris, which is larger than the film thickness, passing through

the oil film. The debris may embed itself in the soft babbitt, exhibiting a short arc on the shoe surface, ending at the point where the debris becomes embedded. Depending on the debris size, the scratch may continue across the entire shoe surface.

Abrasion damage becomes worse with time. Surface scratches allow an escape for lubricating oil in the oil wedge, decreasing the film thickness. This will eventually lead to bearing wipe.

In order to eliminate abrasion damage, the lubricating oil must be filtered. If the oil cannot be filtered or has degraded, it should be replaced. It is important to evaluate the filtering

In addition to filtering/replacing the oil, the entire bearing assembly, oil reservoir and piping should be flushed and cleaned. The original bearing finish should also be restored. Journal shoes typically must be replaced, but if the correction leaves the bearing within design tolerance, the bearing may be reused.

Although the babbitted surface is usually damaged more severely, the rotating collar or journal surface must also be evaluated. Debris partially lodged in the babbitt may score the steel surfaces. These surfaces must be restored by lapping or hand stoning.

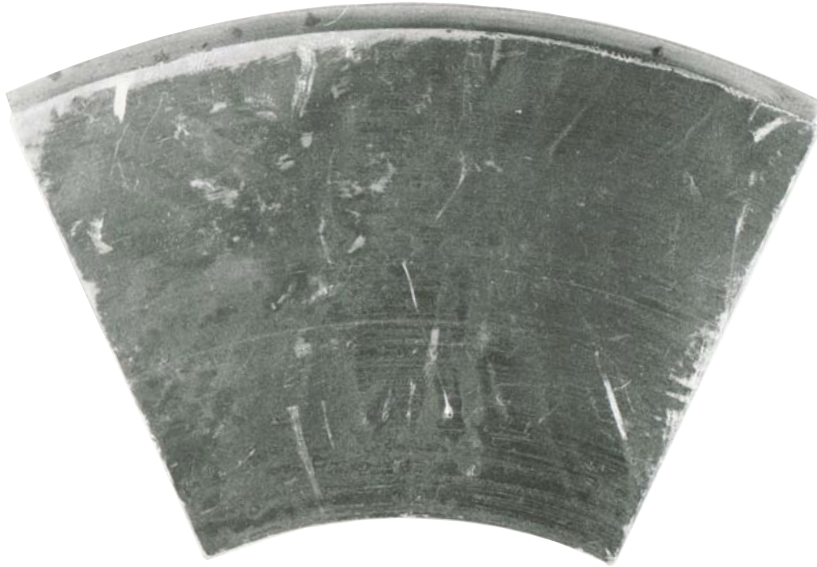
**Figure 16** Tin Oxide Damage

This is one of several electrochemical reactions which eliminate the embedability properties of a fluid-film bearing. Tin oxide damage (Fig. 16) is recognizable by the hard, dark brown or black film that forms on the babbitt.

Tin oxide forms in the presence of tin-based babbitt, oil and salt water, beginning in areas of high temperature and pressure. Once it has formed, it cannot be dissolved, and its

hardness will prevent foreign particles from embedding in the bearing lining. This allows abrasion damage to occur. Pieces of tin oxide may break off during operation and score the journal, collar, or runner. The formation of tin oxide will also eliminate bearing clearance.

This damage may be stopped by eliminating some or all of the contributing elements. The lubricating oil must be replaced. A reduction in oil temperature may also discourage the formation of tin oxide.

In addition to replacing the oil, the entire bearing assembly, oil reservoir and piping should be flushed and cleaned with mineral spirits. The bearing shoes should be replaced. The condition of the rotating journal, collar or runner surfaces must also be evaluated. They must be restored to original condition, either by lapping, hand stoning or replacement.

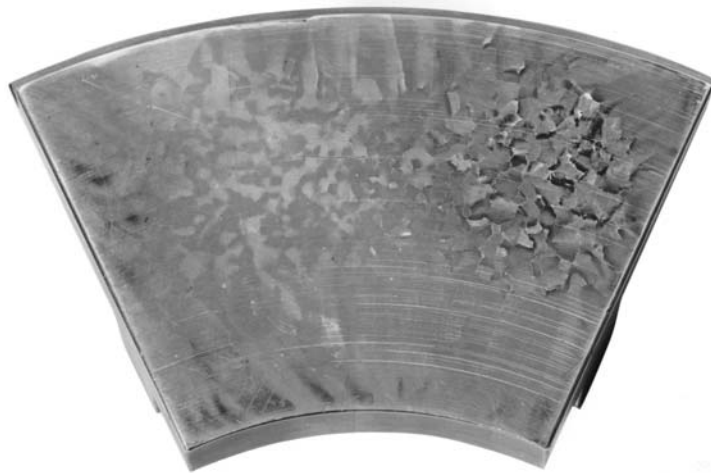
**Figure 17 Thermal Ratcheting**

Overheating damage may represent itself in many ways, such as babbitt discoloration (Fig. 18), cracking, wiping or deformation. Repeated cycles of heating may produce thermal ratcheting (Fig. 17), a type of surface deformation that occurs in anisotropic materials. These materials possess different thermal expansion coefficients in each crystal axis.

If thermal ratcheting has occurred, examine the shoes for the existence and depth of cracks. Remove the cracks and restore the original shoe surface. If this cannot be done, replace the shoes. Journal shoes typically must be replaced, but if the correction leaves the bearing within design tolerance, the bearing may be reused.

The condition of the rotating journal, collar or runner surfaces must also be evaluated. It must be restored to original condition, either by lapping, hand stoning or replacement.

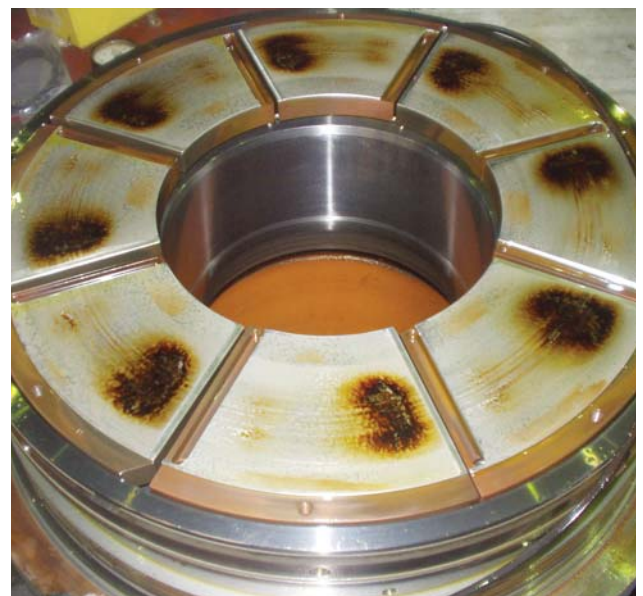
**Figure 18 Overheating, Oil Additives Plated Out**

Overheating may be caused by numerous sources, many of which concern the quantity and quality of the lubricant supply. Among the possible causes are:

Verify that the quantity and quality of oil flowing to the bearing is sufficient. These values should be available from the bearing manufacturer.

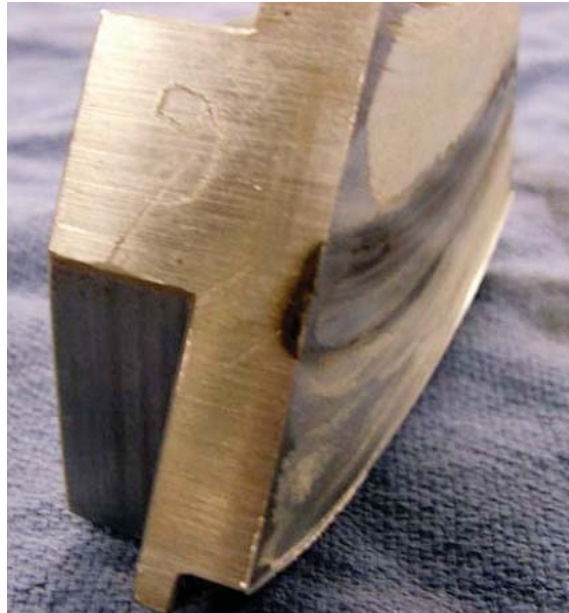
**Figure 19** Tilting Pad Showing Complete Babbitt Removal

In Fig. 19, the babbitt has been completely removed from the shoe surface. If there had been any oil flow to the bearing, it would have sufficiently cooled the region to allow the molten babbitt to at least solidify and accumulate between the shoes. With no oil coming in at the leading edge of the shoe, this area typically shuts down, resulting in the babbitt being eliminated in the corner near the outer diameter in Fig. 20.

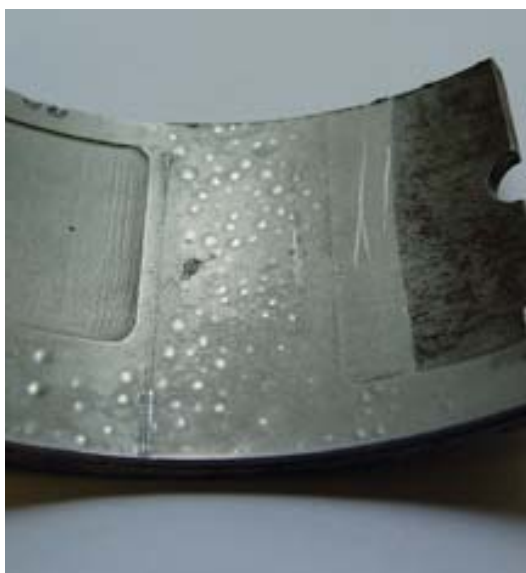
Figure 22 Hydrogen Blisters In The Babbitt

In certain occasions, hydrogen gas becomes trapped during the casting or forging of parts made of steel. If the steel base is babbitted and the gas eventually migrates to the surface, blisters can form in the area, significantly weakening the babbitt bond (see Fig. 22).

Thermal annealing has been proven to prevent blisters from forming by diffusing out hydrogen before the part is babbitted. In Figure 23, the annealing process was accidentally missed and large hydrogen blisters emerged during the machining process.

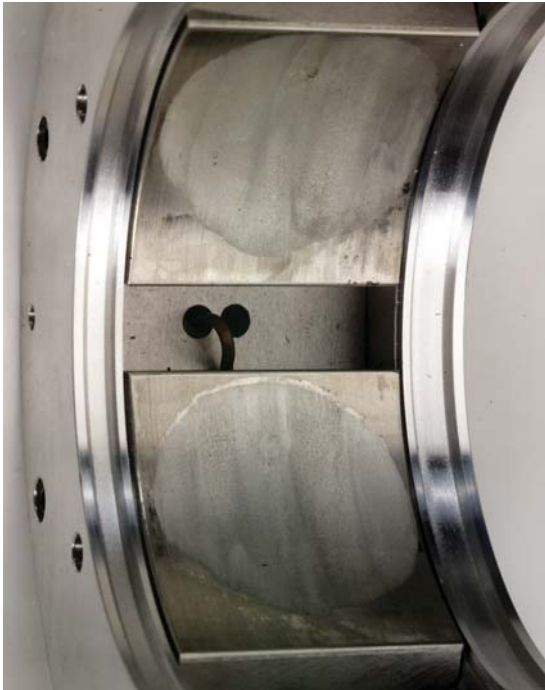
**Figure 24 Stray Shaft Currents/  
Electrical Pitting (Frosting)**

Electrical pitting (Fig. 24) appears as rounded pits in the bearing lining. The pits may appear frosted, or they may be blackened due to oil deposits. It is not unusual for them to be very small and difficult to observe with the unaided eye. A clearly defined boundary exists between the pitted and unpitted regions, with the pitting usually occurring where the oil film is thinnest. As pitting progresses, the individual pits lose their characteristic appearance as they begin to overlap. Pits located near the boundary should still be intact. The debris that enters the oil begins abrasion damage. Once the bearing surface becomes incapable of supporting an oil film, the bearing will wipe. The bearing may recover an oil film and continue to operate, and pitting will begin again. This process may occur several times before the inevitable catastrophic bearing failure.

Electrical pitting damage is caused by intermittent arcing between the stationary and rotating machine components. Because of the small film thicknesses relative to other machine clearances, the arcing commonly occurs through the bearings. Although the rotating and other stationary members can also be affected, the most severe pitting occurs in the soft babbitt.

This type of shaft current can be eliminated with a grounding brushes or straps. Bearing isolation is also recommended.

The lubricating oil must be filtered or replaced. Pitting damage often blackens the oil and fills it

The original bearing finish should also be restored. Journal shoes typically must be replaced, but if the correction leaves the bearing within design tolerance, the bearing may be reused. The condition of the rotating journal, collar or runner surfaces must also be evaluated. It must be restored to original condition, either by lapping, hand stoning or replacement.

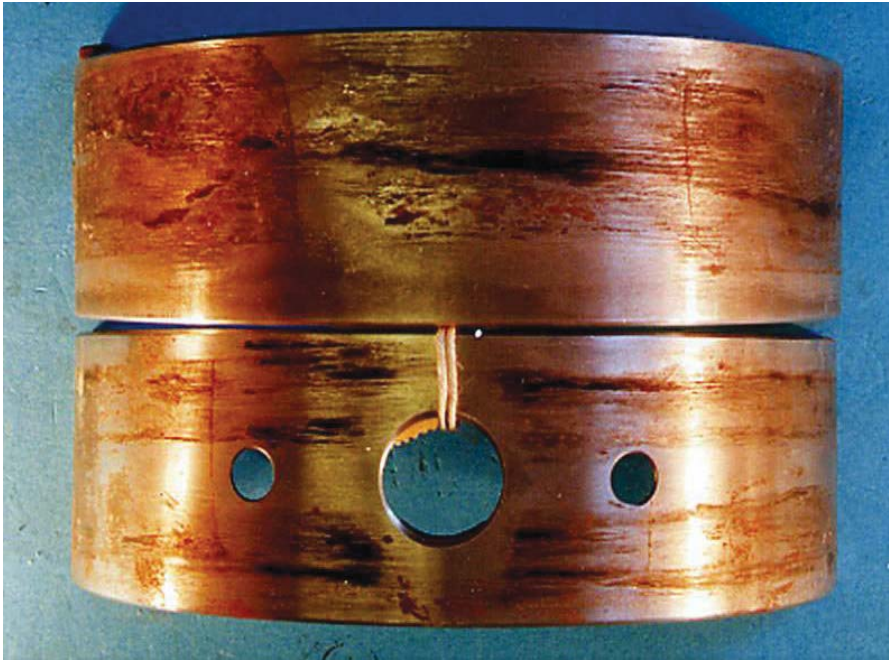
**Figure 28 Fretting Corrosion of Shell And Housing**

Prime examples are the contact areas between shoe supports and leveling plates, journal bearing shells and the housing (see Fig. 28), and parts with an interference fit, such as the collar and shaft. As can be noted in the photograph, fretting corrosion is characterized by a red-orange iron oxide, which forms on the freshly “machined” steel surfaces. To reduce the risk of recurrence, the replacement parts should be adjusted to obtain a better fit that eliminates the oscillations.

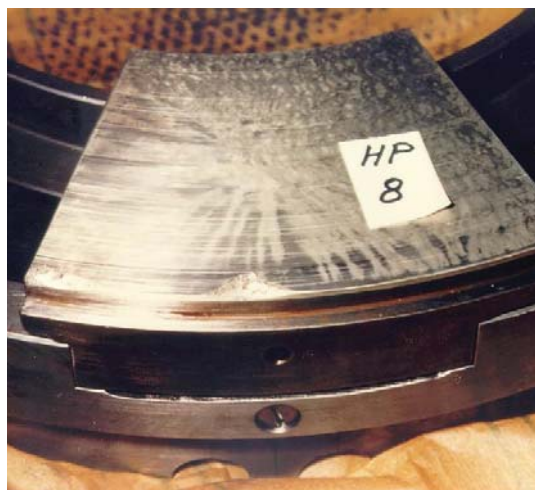
**Figure 32 Thrust Shoe Cavitation Towards Outside Diameter**

Often called cavitation erosion, cavitation damage (Fig. 32 and 33) is caused by the formation and implosion of vapor bubbles in

areas of rapid pressure change. Damage often occurs at the outside diameter of thrust bearings due to the existence of higher velocities. This type of damage can also affect stationary machine components in close proximity to the rotor.

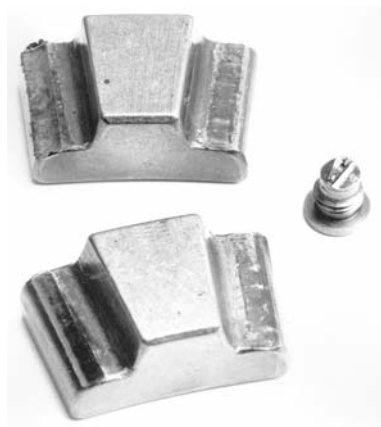
**Figure 36** Leveling Plate Wear Due To Collar Wobble

If the collar is not within tolerance, the resultant "wobble" (Fig. 36) will force the shoes and leveling plates to constantly equalize, causing rapid leveling plate wear.

It is very important that the collar faces be parallel, and perpendicular to the centerline of the shaft.
