TURBOMACHINERY & PUMP SYMPOSIA | HOUSTON, TX
AUGUST 20-22, 2024
SHORT COURSES: AUGUST 19, 2024

THRUST BEARING FAILURE IN A LARGE LNG REFRIGERATION COMPRESSOR

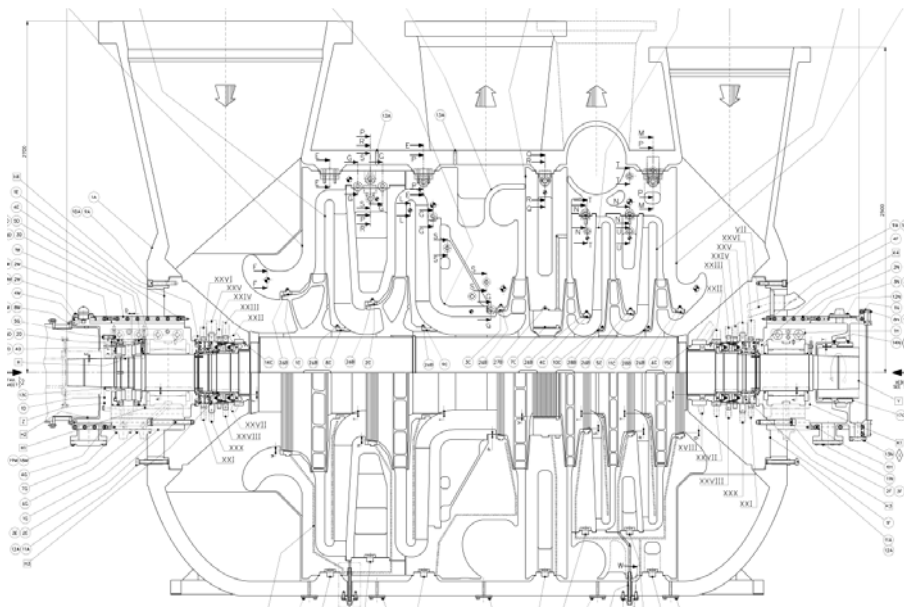
FIGURE 1. Cross-section of two section refrigeration compressor

An LNG facility contained two identical compression trains each driven by a gas turbine and a helper motor. As is common with LNG facilities the compressor was rather large with a power requirement of approximately 45 MW. Because of space and arrangement limitations the decision was made during the design phase to combine the compressor into a two-section, back-to-back configuration (see Figure 1).

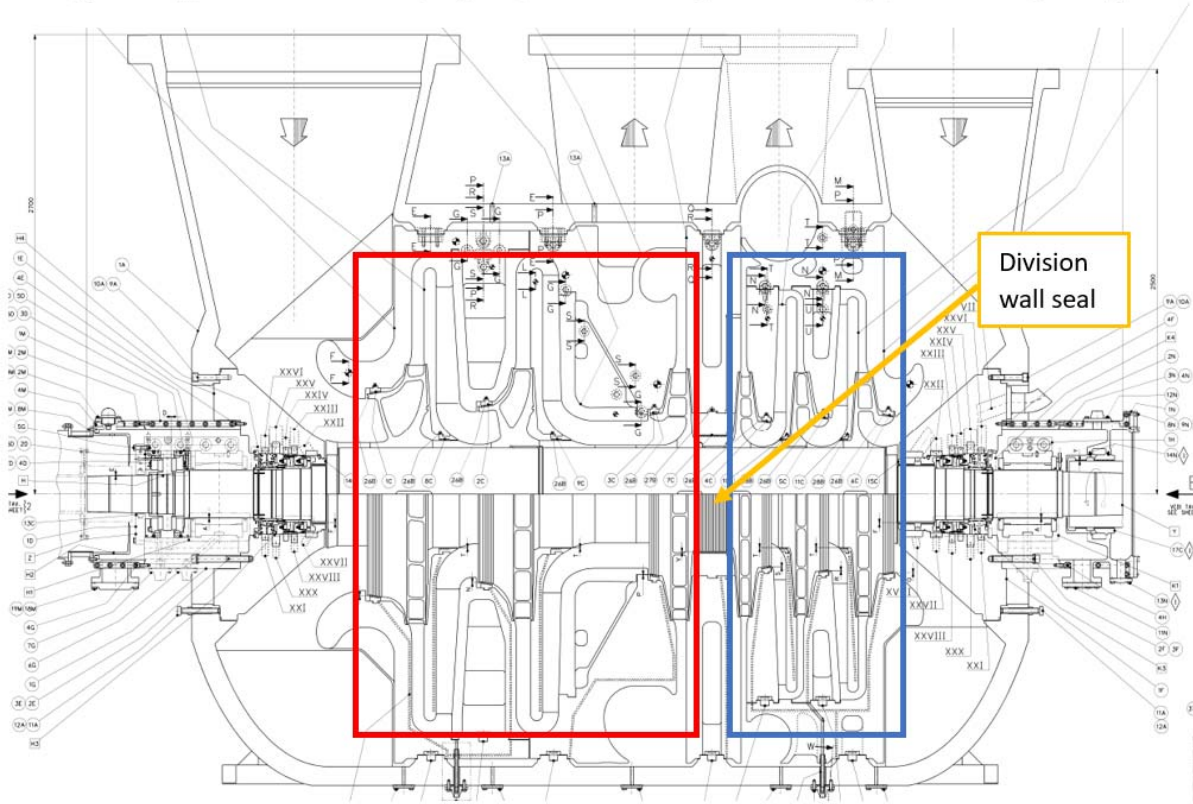
FIGURE 11. Cross-sectional drawing of compressor with LP (red) and HP (blue) outlined

when it shuts down. When a compressor is running the gas pressure varies from suction to discharge inside the compressor and associated piping. However, when the compressor shuts down, the gas equalizes to one pressure that is based on the mass of gas inside the fixed volume of the compressor casing and piping. The compressor is a back-to-back compound configuration which is similar to having two compressors (Low Pressure (LP) and High Pressure (HP)) in one casing (Figure 11). During operation a small amount of gas leaks across the division wall seal between the two sections.

The initial settle-out to two different pressures causes a high thrust load on the rotor pushing it in the active direction (right to left in Figure 11). High speed process data was obtained from the anti-surge controller for a trip of the compressor on 13 August 2017 (Figure 13). The gold line is the calculated thrust load and the green line is the speed. As described above, the peak thrust load occurs about 25 secs after the machine trips when the speed is approximately 1500 rpm. Notice the similarities between the thrust temperature in Figure 10 above and the calculated thrust load in Figure 13 below. The two trends are very representative of each other. A more severe trip occurred on the other compressor on 25 June 2017 when the HP discharge pressure was higher, see Figure 14. The large differential

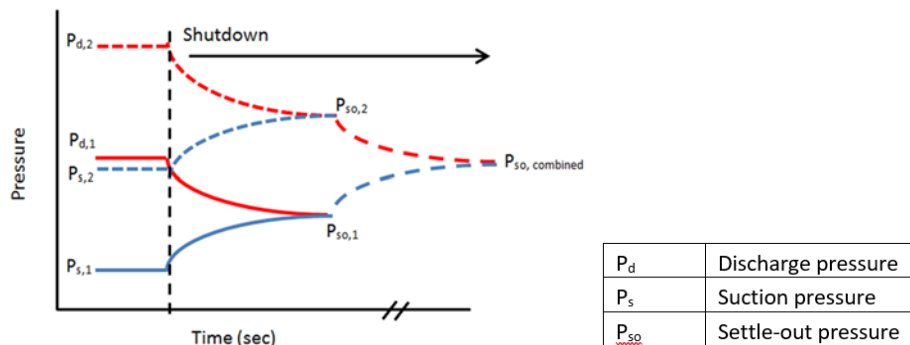
FIGURE 12. Typical settle out of compound compressor

When the compressor trips, all the gas in the LP section equalizes to one settle-out pressure, while the gas in the HP section equalizes to a higher settle-out pressure. At the same time, gas leaks across the division wall, and the two sections equalize to one common settle-out pressure. This transient event is graphically illustrated in Figure 12. The first settle-out to the two separate pressures occurs very rapidly, typically less than 10 secs. The subsequent combined settle-out can take much longer because it is controlled by the leakage rate across the division wall seal, not the thermodynamics of the gas.

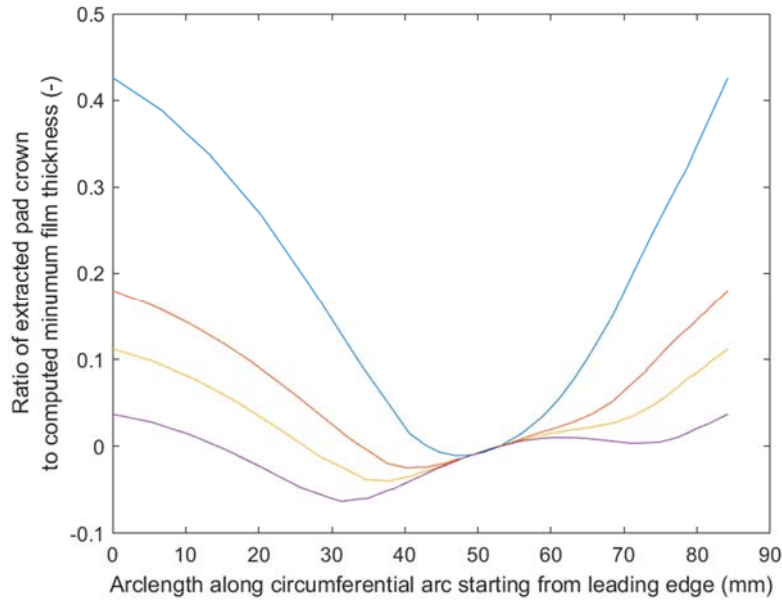
FIGURE 17: Ratios of pad crown to minimum film thickness along the circumferential path extracted from the TEHD code calculations for a sequence of increasing shoe support radii, where blue is the smallest and purple is the largest.

The trends in Figs 17-18 show that the pad crown reduces as the shoe support radius increases. Similar graphs for fixed pad-support radius and varying thicknesses also show that a similar trend—pad crown diminishes with the decrease in pad-support thickness. The bearing OEM extrapolated that that the design shown in Fig. 16 will have the smallest shoe crown.

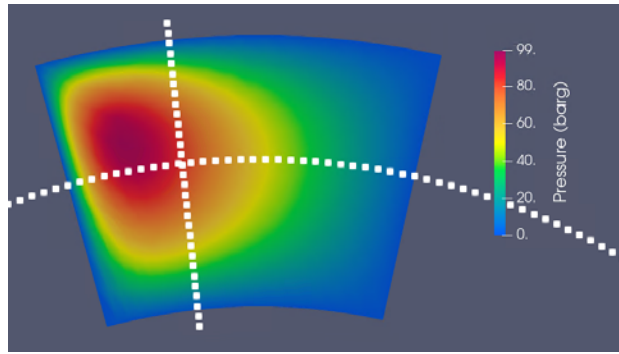
FIGURE A-1: Circumferential and radial paths along which the deflection field is extracted. The contours are those of the pressure field generated by the TEHD code for a 222kN load operating at 2200 rpm.

For the sake of simplicity, we examined the crown of the pad along two curves projected onto the surface of the pad as shown in Fig. A-1. The circumferential and radial paths pass through the center of the pad-support. Note that the peak pressure in Fig. A-1 is not located over the pad-support directly; rather, it is the center of pressure that is located over the pad-support. The pad deflection in the axial direction can be interpolated from the TEHD code's computation grid (Fig. A-2) onto these curves using common plotting software, e.g. ParaView (Ayachit 2015).

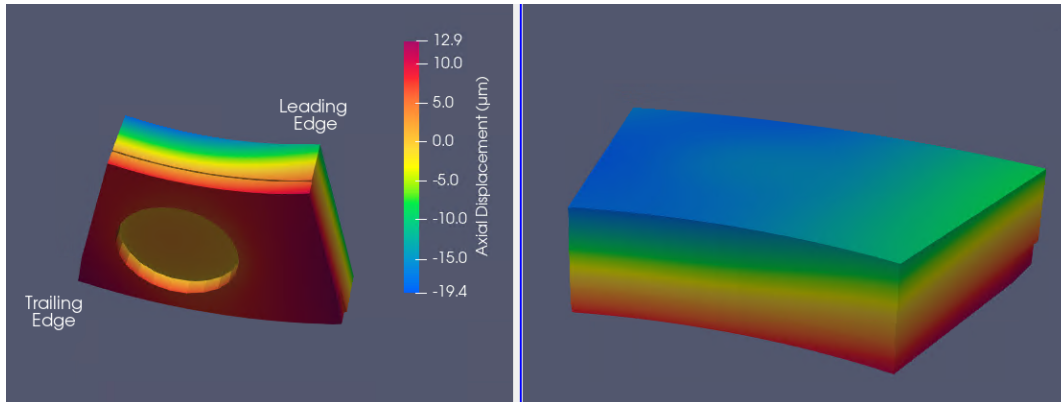
FIGURE A-2: Pad deflection data computed by THRUST corresponding to the operating conditions in Figure 17 as viewed from below (left) and above (right).

One now must extract the pad crown from the deflection data. Since we are looking at a converged solution in the code, the pad has undergone tilt and roll motions as well as thermal expansion and mechanical compression, all of which is reflected in the output data in Fig. A-2. The sign convention is defined by the code: positive values in Fig. A-2 correspond to deflections away from the pad surface toward the base ring, and negative ones correspond to deflections into the fluid domain. The top view in Fig. A-2 shows that most of the surface of the pad deflects into the fluid due to the zero-deflection boundary condition used by the TEHD code at the circumferential edge of the pad-support-to-pad-body interface. Consequently, the extracted raw data along the circumferential curve in Fig. A-1 is shown in the blue curve in Fig. A-3. The deviation of this data from a line connecting the two ends (orange line in Fig. A-3) is the pad crown (green arrows in Fig. A-3). Similarly for the radial curve. Note that the zero of the x -axis in Fig. A-3 starts at the leading edge of the pad; that is to say, the sense of rotation has been removed from the graph.
