Spring Plate Bearing Retrofit Project

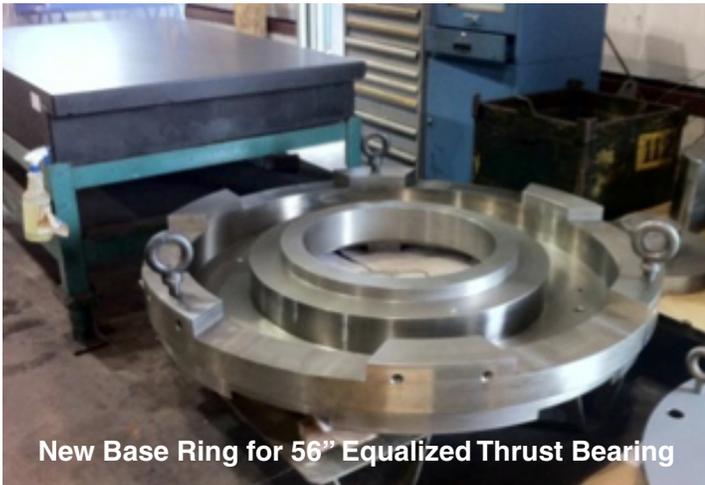
New Base Ring for 56" Equalized Thrust Bearing

To address this common problem, Kingsbury engineers designed a retrofit KBV-style bearing to fit in the same envelope as the existing one, but with the added advantage of individual tilting pads supported on a series of leveling plates to provide misalignment capability and compensate for minor shaft wobble.
